INCIDENT FACTS

71-255-2024

Gutter Installer Falls from Patio Roof

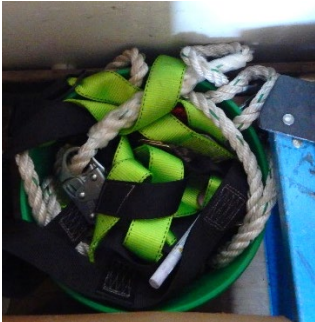
Personal fall protection harness, lifeline, and lanyard available in the work truck.

The employer, who had just arrived, and homeowner found him at approximately 7 a.m. on the patio with his pry bar nearby. He was wearing a tool belt but not the personal fall protection equipment that was available in the work truck. Emergency responders declared him dead at the scene.

- Develop a formal, written APP. See [WAC 296-800-14005](#)
- Develop and implement a written fall protection work plan, including each area of the work place where the employees are assigned and where fall hazards of ten feet or more exist. See [WAC 296-880-10020\(1\)](#)
- Ensure that each employee on a walking/working surface with an unprotected side or edge four feet or more above the ground or lower level is protected by a fall protection system. See [WAC 296-880-20005\(1\)](#)
- Provide training for each employee exposed to fall hazards. See [WAC 296-880-10015](#)
- Document attendance and subjects discussed at crew-leader safety meetings. See [WAC 296-155-110\(6\)](#)

- Arrive on-site before work begins or appoint a supervisor to ensure that workers use fall protection and follow fall prevention safe work practices.
- During the pre-job safety meeting, go over the fall protection work plan and discuss workers' responsibilities and the details of how they will implement the plan.
- Make fall prevention a company priority and emphasize to workers to always use fall protection when required.

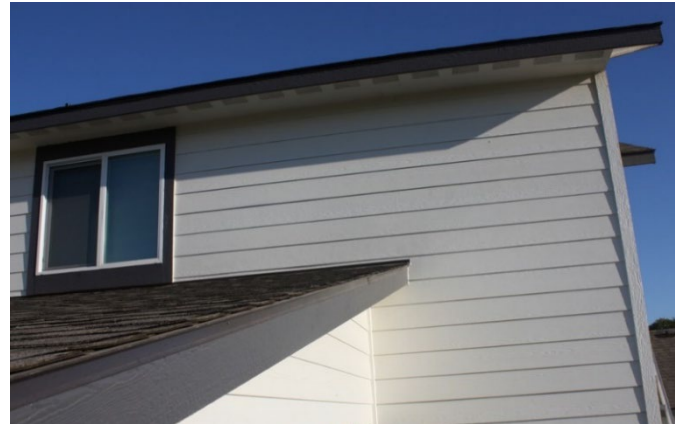
While standing on the patio roof, the installer started prying between the upper roof shingles and the fascia in order to make a space to attach the gutter flashing. As he continued prying toward the corner of the upper roof, he reached the edge of the patio roof on which he was standing. He either did not see the patio roof edge and stepped off or was extending his reach and lost his balance. He fell 13 feet to the concrete patio.

Patio roof (in the lower left of photo) where the installer was standing and prying on the upper roof when he fell.
